Bonded Repair of a Gun Carriage Using Electroformed Nickel Reinforcements

Air Vehicles Division Defence Science and Technology Organisation

DSTO-TR-1930

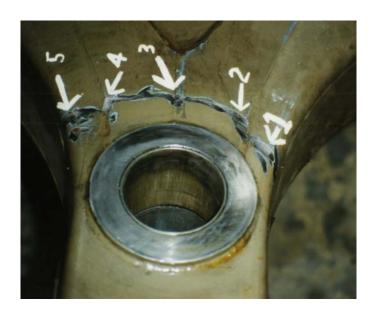
Gun trails are subject to damage from several sources. An example is fretting or abrasion caused by metal chains used inadvertently to immobilize the trails during transportation. Figure 2 shows a particularly severe example of damage caused in this way to the boss region circled in Figure 1; the damage is somewhat less severe than it appears in the figure as it is highlighted by damage to the paint film. Repair of damage in this trail was not attempted, but a trail with similar but less severe damage, Figure 3, was repaired.

Figure 2 Gun trail showing severe chain scored region \sim 20 mm from boss rim; the region is shown circled in Figure 1- the arms extend from the top of this photograph

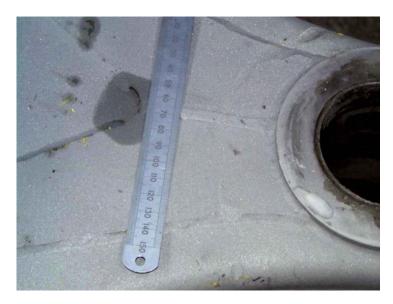
Figure 3 Gun trail showing chain scored region, selected for repair study

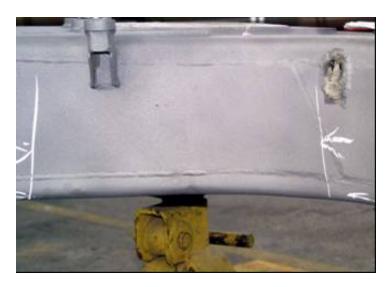
Other examples of damage, shown in Figure 4, likely caused by boulder impact and in Figure 5 caused by abrasion to the trail from metal fittings by contact with metal fittings. Further damage was caused by spikes in the firing platform when the platform was being manipulated for transportation. Whilst, in most cases the damage was quite shallow so did not appear to be a serious threat to the integrity of the trails, on the basis of the advice provided by the OEM, any visible damage is grounds for rejection or repair. However, the sharp grooves caused by the firing platform spikes were smoothed out by sanding to reduce the stress concentration.

Figure 4 Gun trail showing damage to the base of the box section selected for repair study

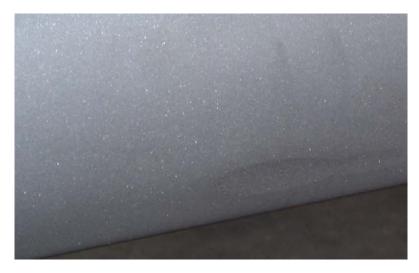
Figure 5 Gun trail showing damage to the arm, selected for repair study

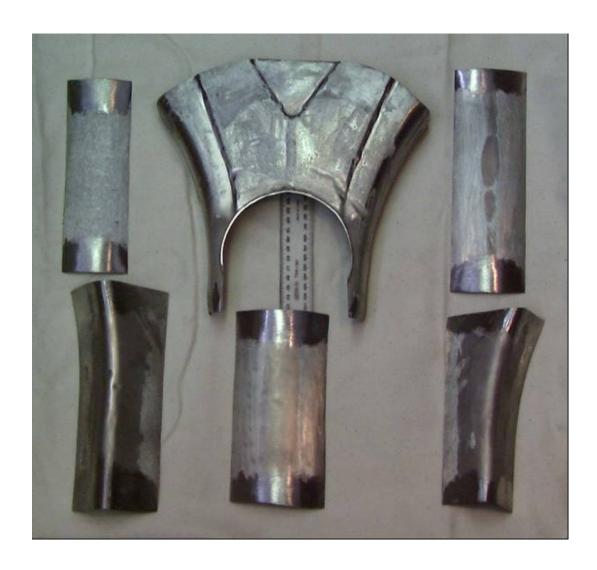
Figure 10 shows the resulting reinforcements. Note the high level of fidelity in the larger electroform, including the damage indentation (which ideally should have been filled in prior to making the mould).

Figure 10 Electroformed reinforcements, clockwise from the top left regions D, A, E (outer) and B, E (inner) and C

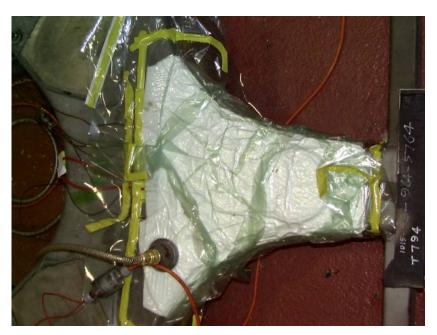
Figure 14 Application of the reinforcement region A in the boss region, showing vacuum bagging assembly

The reinforcements were bonded to the gun trails using a silicon-rubber heater blanket to heat the structure and a vacuum bag to apply atmospheric pressure. Two layers of FM73 adhesive were cut to the size of the reinforcement and the adhesive was placed over the damaged region of the trail. The heater blanket was placed over the reinforcement with thermocouples to monitor and control temperature and a bleeder cloth was placed over the heater to provide a passage for expulsion of air etc. A nylon vacuum bag was then formed over the assembly and sealed with butyl rubber. The finished vacuum-bag assembly is shown in Figure 14 for the doubler applied to the boss region of the trail. Cure of the adhesive was achieved at a temperature 120° C for four hours under atmospheric pressure.

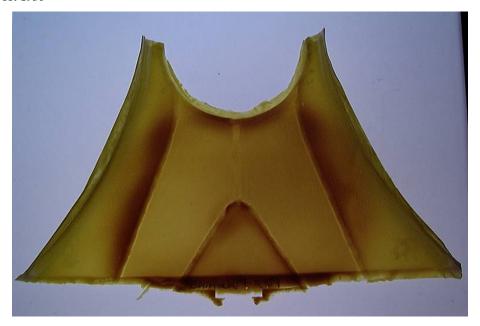
Prior to actually bonding the reinforcements a test was conducted to evaluate adhesive flow and integrity. This was done by setting up the vacuum bag assembly as just described and placing a layer of release film on either side of the adhesive. Following the cure procedure the adhesive was released and inspected for flow and voids. Figure 15 shows that the adhesive layer exhibited good flow and little voiding

Figure 15 Flow test specimen for adhesive showing excellent flow and low voids

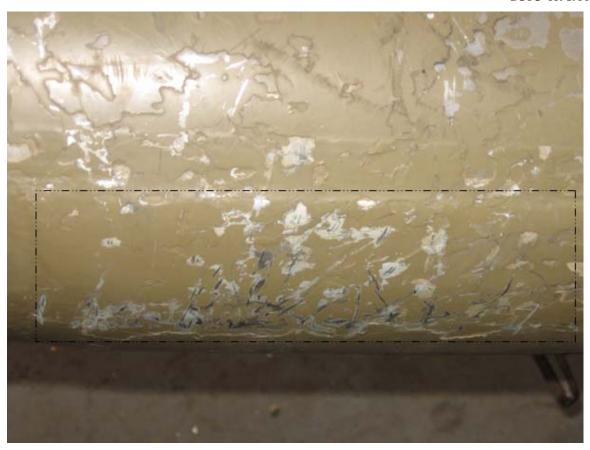
All the reinforcements appeared to be in excellent condition with no evidence of disbonding - indicating that no fatigue or environmental degradation has occurred.

However, as shown in Figure 20 there is evidence of significant mechanical contact in the form of extensive chips and scratches to the paint scheme. The observation justifies the choice of nickel for the reinforcements; if polymer-matrix composite reinforcements had been used severe damage would almost certainly have occurred. Refurbishment of the trails involves removal of the paint scheme by grit blasting followed by steam cleaning prior to re-coating – this could prove damaging to a polymer composite reinforcement, unless very carefully undertaken. For the electroformed reinforcements, the only caution given is to avoid removal of the epoxy coating at the reinforcement edges – or replacement prior to painting if removal occurs.

Figure 20 Reinforcement from region E, showing mechanical damage after three years of active service. No evidence was found of disbonding in this or any of the other reinforcements
